PINOLE SLIDE
I-80, CALIFORNIA

by: Travis W. Smith
Supervising Highway Engineer

Rogel H. Prysock
Associate Materials and Research Engineer
and
John Campbell
Highway Engineering Technician I
Materials and Research Department
Division of Highways,
Sacramento, California

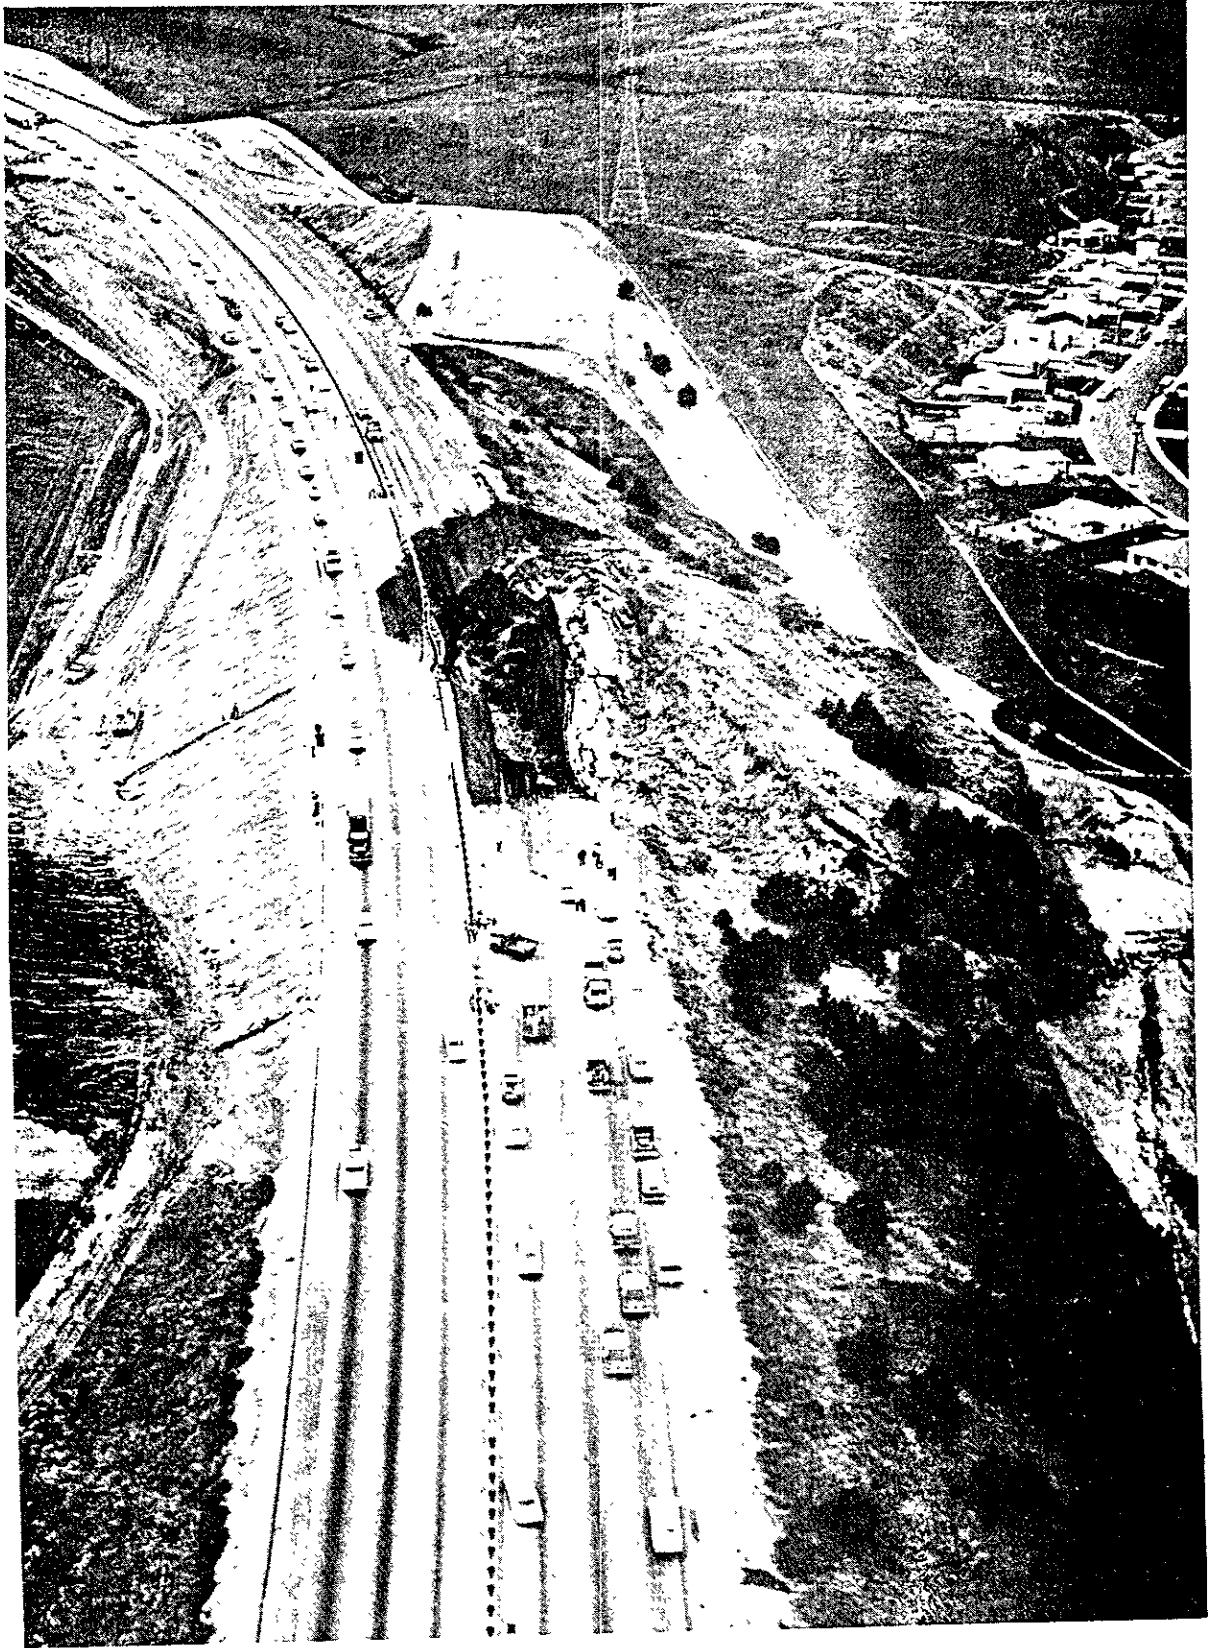
On Tuesday, May 6, 1969, indications of distress in the form of cracking and settlement appeared on a portion of the pavement of Interstate Route 80 near Pinole, California. Efforts to restore the damaged surface of the heavily traveled freeway during the next few days were ineffective as the deterioration of the roadway progressively worsened. It soon became apparent that the distress reflected an unstable condition within the embankment or its underlying foundation, and by Sunday morning, May 11, the prospect of a massive failure appeared imminent. It was therefore decided to close the road at midday in the interest of public safety. The Highway Patrol was notified, traffic was diverted, and police forces in nearby cities were alerted to prepare for unusual traffic over alternate routes. A few hours after these precautions were taken, over 400 feet of embankment slid out leaving a single lane of the roadway in place, as shown in Photographs 1 and 2.

Photograph No. 1 - Aerial photo of slide, looking westerly

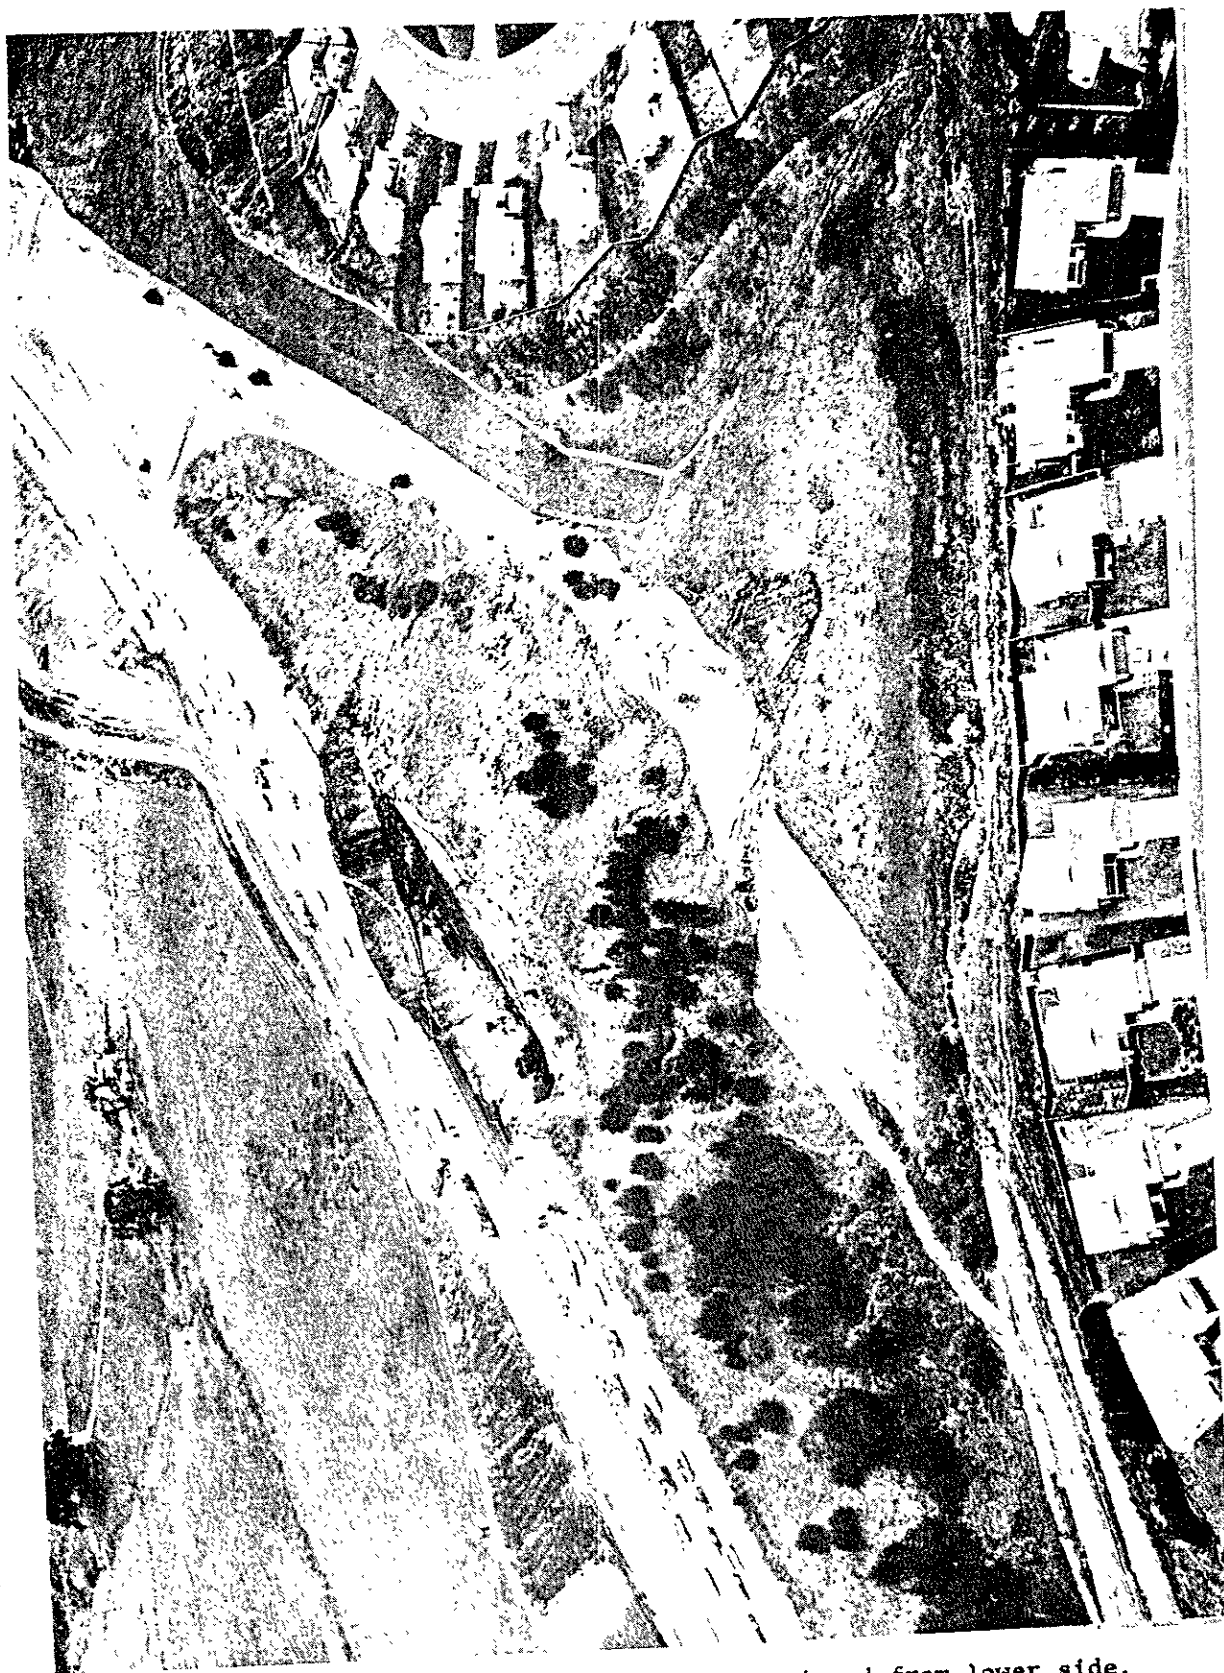
Photograph No. 2 - Aerial photo of slide, viewed from lower side.

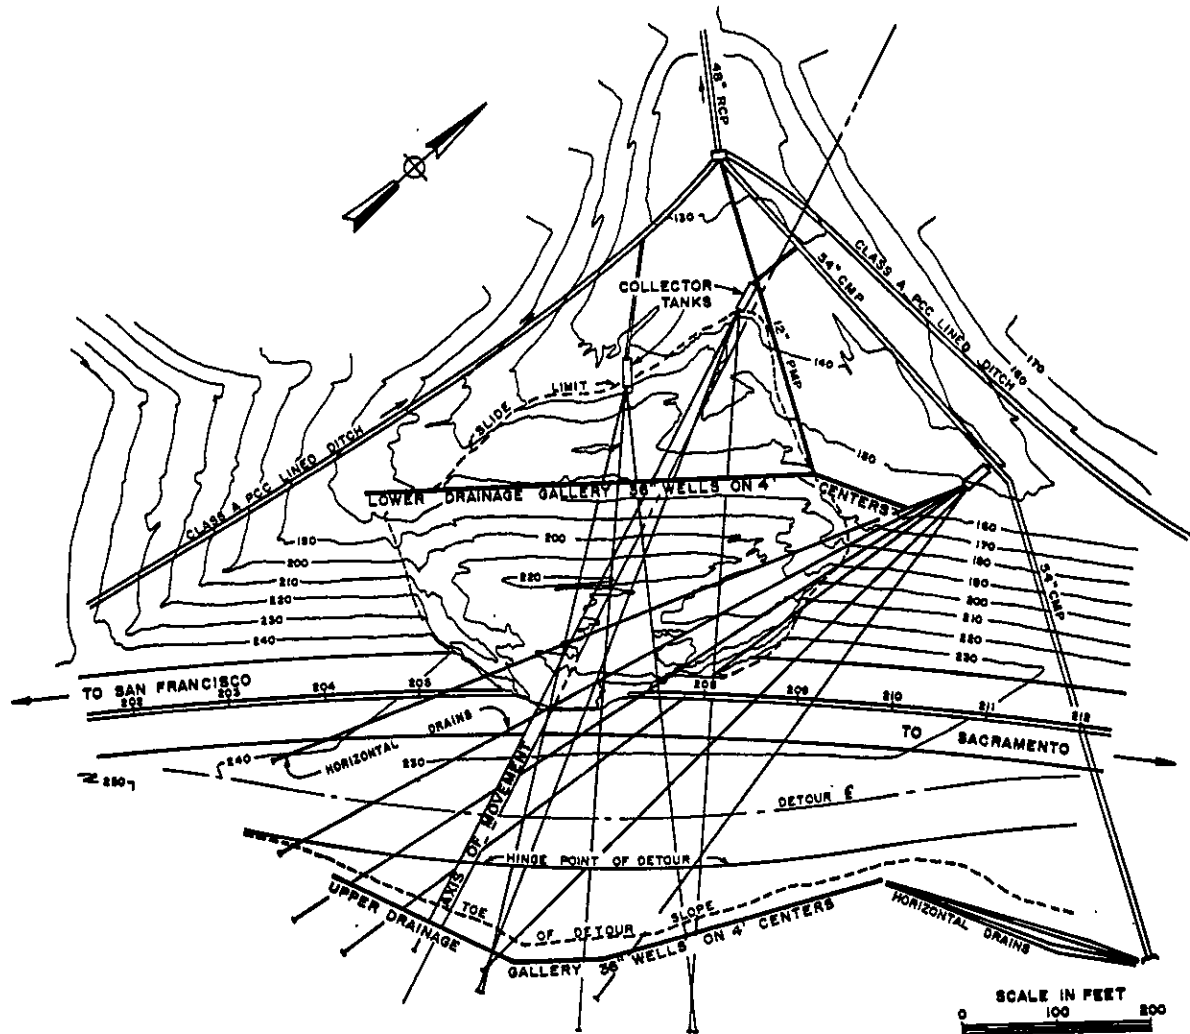
PLAN OF FAILED AREA
STA. 202 TO STA. 212

It became evident within a few days that ground water in fairly large quantity was present under the failed area. Ground water encountered at depths of 20 to 25 feet below ground surface near the toe of the detour embankment rose 10 to 15 feet in the bore holes. Ground water was also observed near the toe of the slide under a slight head. These observations indicated that excessive amounts of seepage water had become entrapped beneath the embankment and that the resultant hydrostatic pressures had triggered the failure in the embankment foundation.

Twelve horizontal drains were installed in fan patterns from three locations at two different elevations. These drains, varying between 550 and 830 feet in length, produced a total flow of 10,000 to 12,000 gallons per day, the largest flows having been produced by a group of three drains drilled into the center of the failed area. Location of horizontal drains is shown in Figure 2. During the six-week period following their installation, these drains lowered ground water 7 feet at the toe of the detour, 2.3 feet beneath the central portion of the slide mass, and 1 foot at the toe of the slide.

Figure 2 - Plan of failure area showing drainage system and detour

gallery on the high side of the fill is drained laterally to a collecting basin at ground surface by means of a 6-inch steel pipe supplemented by a group of three short horizontal drains. From this point the cumulative flow is conducted beneath the embankment to the drainage disposal area through a 54-inch by 990-foot CMP. A 12-inch by 350-foot perforated metal pipe laid in an excavated trench bedded with gravel drains the lower gallery to the master drain junction box (see Figure 2).

The 12 horizontal drains installed to relieve ground water pressure were incorporated into the permanent drainage system. Three 32-foot lengths of 120-inch multiplate pipe fitted with concrete ends to form tanks were utilized to collect flows from the three groups of drains. Water collected in the tanks exited through small conduits into the large 54-inch pipe drain and into the open PCC lined ditches that function as surface drains along the toes of the embankments (see Figure 2).

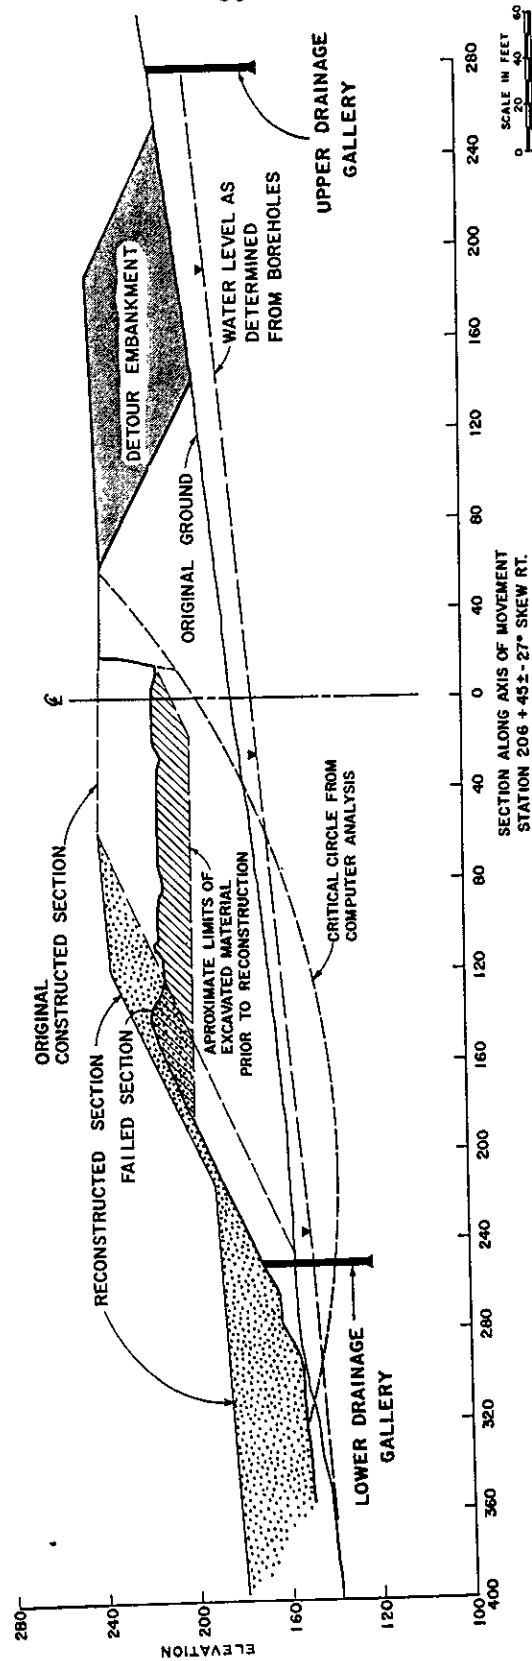
factor. For the conditions analyzed, a minimum safety factor of 1.01 was obtained for the circle shown on Figure 3.

The mode of failure appears to have been more of the translational type than circular, especially through the lower area of movement. The use of a circular failure surface as an approximation is believed to have been justified since the critical circle was fairly flat through the zone of original ground and conformed reasonably well to the available inclinometer data. Also the safety factor of unity attested to the reasonableness of strength values used in the analysis.

Figure 3 - Cross section along axis of movement, Station 206+45 ±, showing failure plane, reconstruction features and detour embankment

Increased stability of the embankment was provided by the placement of a 25-foot high berm downhill of the roadway, extending laterally 50 feet beyond the downhill limit of movement (see Figure 3). This berm was keyed into the existing subdivision embankments northerly of the original embankment toe. A factor of safety in the order of 1.4 was obtained through employment of the berm.
